4.3.9.1 Unit Type WH.2.W Wherry 2400 Housing

Base Name: Holloman Air Force Base

4.3.9.2 Unit Type WH.2.X Wherry 2400 Housing

4.3.2.1 Unit Type CP.4.G 2710 San Juan Loop Holloman AFB, New Mexico

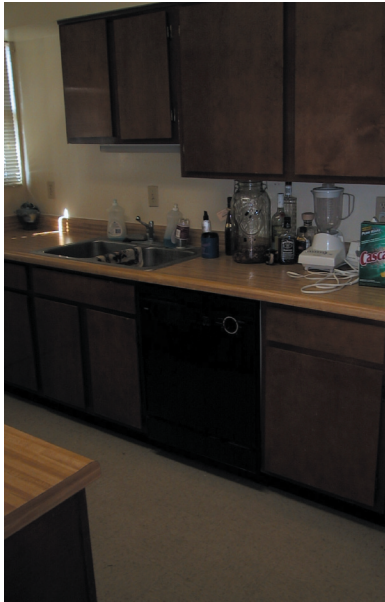
Kitchen

- Cabinets: wood; fair condition; worn finishes.
- Counter Tops: laminated; fair condition; worn finish; some staining.
- Sink: stainless sink, double; fair condition; slightly worn finish.
- Sink Fixtures: metal; fair condition; worn finish.
- Refrigerator: standard; fair condition; worn interior.
- Range/Oven: gas; fair condition; older unit.
- Vent Hood: exhaust fan; fair condition; older unit.
- Dishwasher: standard; fair condition; older heating element.
- Garbage Disposal: standard; fair condition; older unit.
- Flooring: vinyl composition tile; fair condition; slightly worn.
- Walls: gypsum wall board; fair condition; uneven.
- Wall Finish: painted; fair condition; slightly worn; textured finish.
- Ceilings: gypsum wall board; fair condition; worn.
- Ceiling Finish: painted; fair condition; slightly worn.
- Interior Hardware: none; not required.

- Cabinets: refinish wood cabinets.
- Counter Tops: install new counter top.
- Sink: install new stainless steel sink.
- Sink Fixtures: install new sink fixtures.
- Refrigerator: install new refrigerator.
- Range/Oven: install new range/oven.
- Vent Hood: install new vent hood.
- Dishwasher: install new dishwasher.
- Garbage Disposal: install new garbage disposal.
- Flooring: install new ceramic tile floor.
- Walls: replace gypsum wall board.
- Wall Finish: paint gypsum wall board.
- Ceiling: replace gypsum board ceilings.
- Ceiling Finish: paint gypsum board.

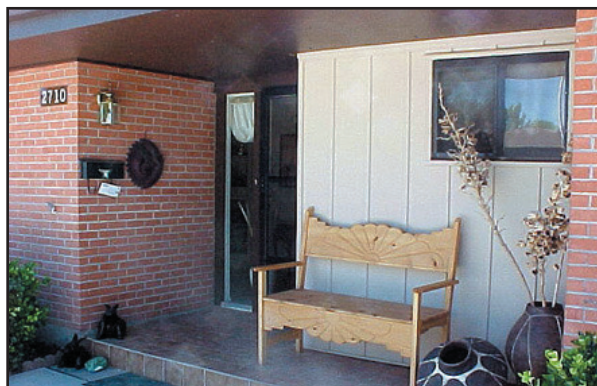
Front Entry

- The insulated bronze anodized aluminum, double-glazed windows are in good condition.
- The vinyl window screens are in good condition.
- The wood entry door and side lights are in poor condition.
- The French doors between the family room and sunroom are in good condition.
- The aluminum storm doors are in fair condition.
- The door hardware is in good condition.

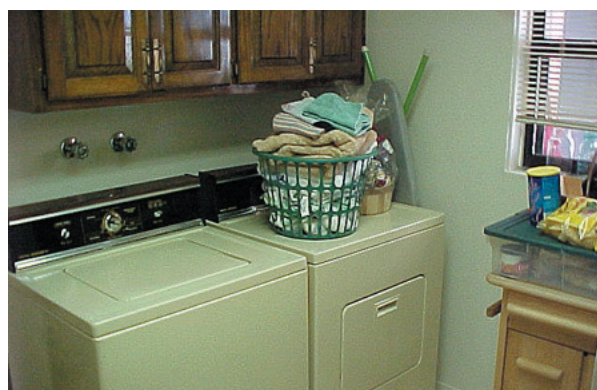
Laundry

- The painted gypsum board walls and ceramic tile wainscoting are in good condition.
- The painted gypsum board ceiling is in good condition.
- Ventilation is through an operable window and a ceiling-mounted exhaust fan in good condition. Ventilation is adequate.
- The interior hardware is in fair condition.

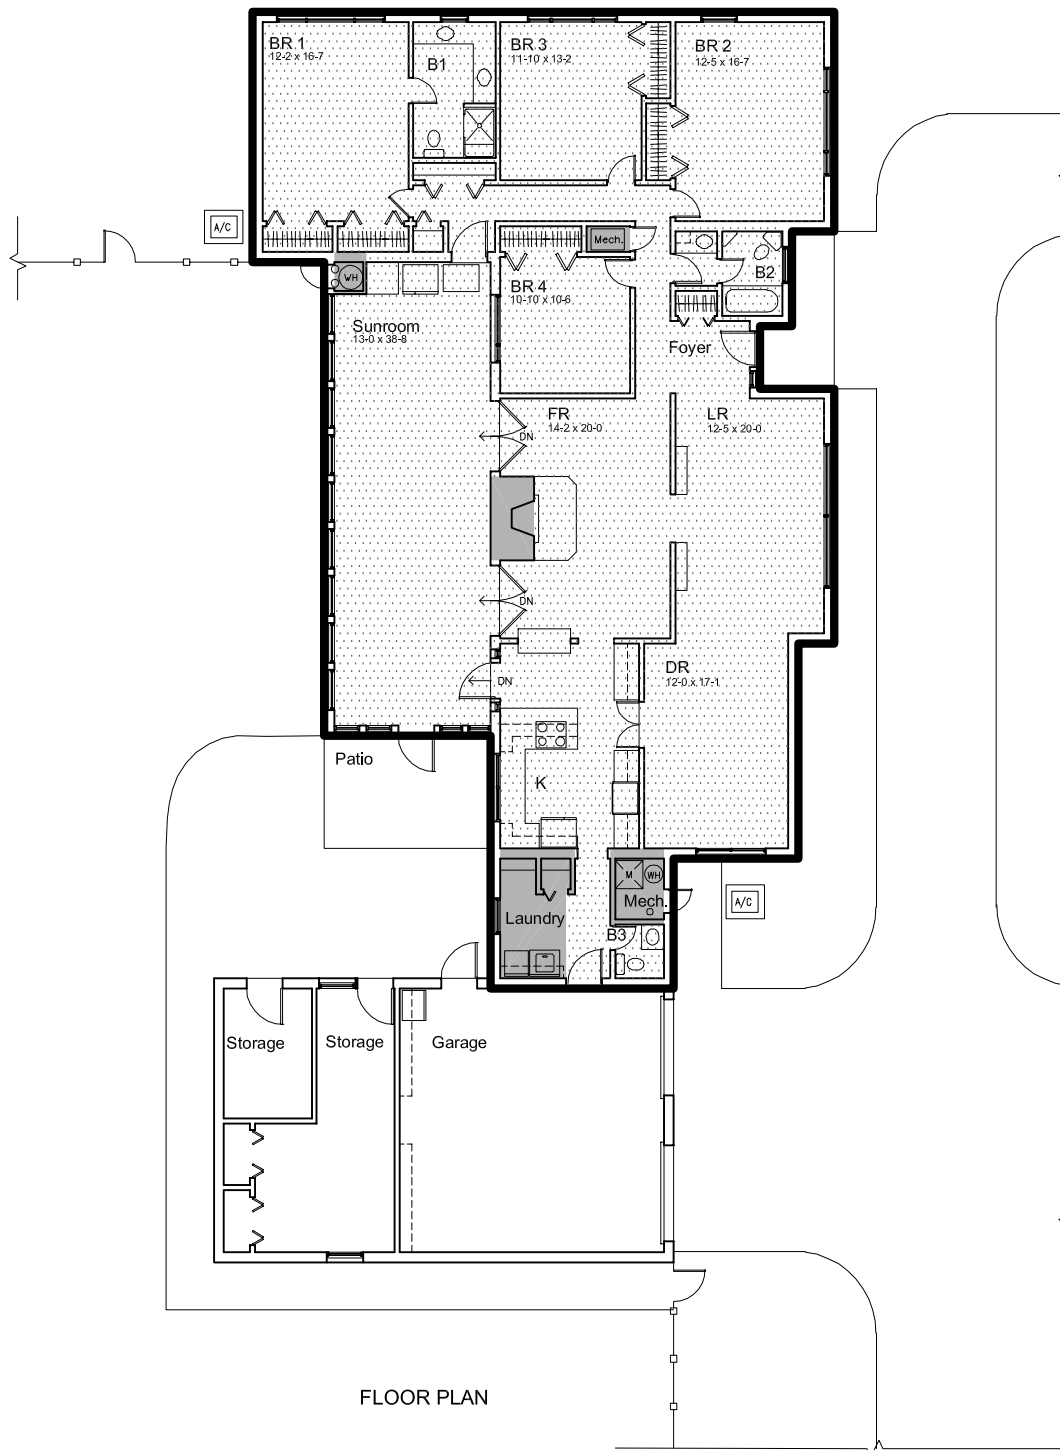
PROPOSED

2710 SAN JUAN LOOP
 4 Bedroom/ GOQ
 GROSS SF: 3033
 NET SF: 2675
